Human Impact on the Headwater Environment In the Uporoto Highlands, Tanzania

*Cosmas H. Sokoni**

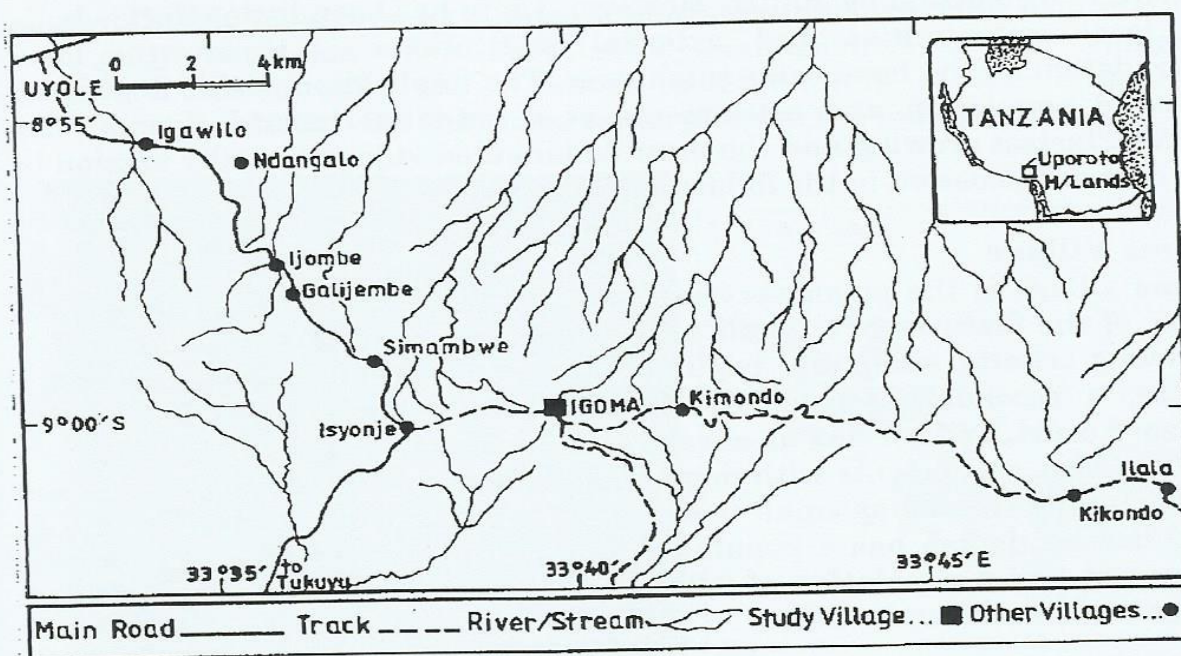
Figure 1: Location of village settlements along the water-divide of the Uporoto Highlands

The UHs form a headwater region for the northeast Ruaha River and Southwest Kiwira River drainage systems. The main streams that feed the Ruaha River are Mwambalizi; Patagwa; Dugumila; Shirisi and Halanzi. Downstream are located land uses of national importance, including rice irrigation schemes of Usangu basin, the Ruaha National Park and the Mtera Dam for hydro electric power generation. Various streams feed into the two main rivers of Kiwira and Mwatisi that drain south-eastwards into Lake Nyasa. The road from Uyole southwards to Isyonje, and eventually eastwards to Kikondo village on the margins of Kitulo National Park, marks the water divide (Fig. 1).

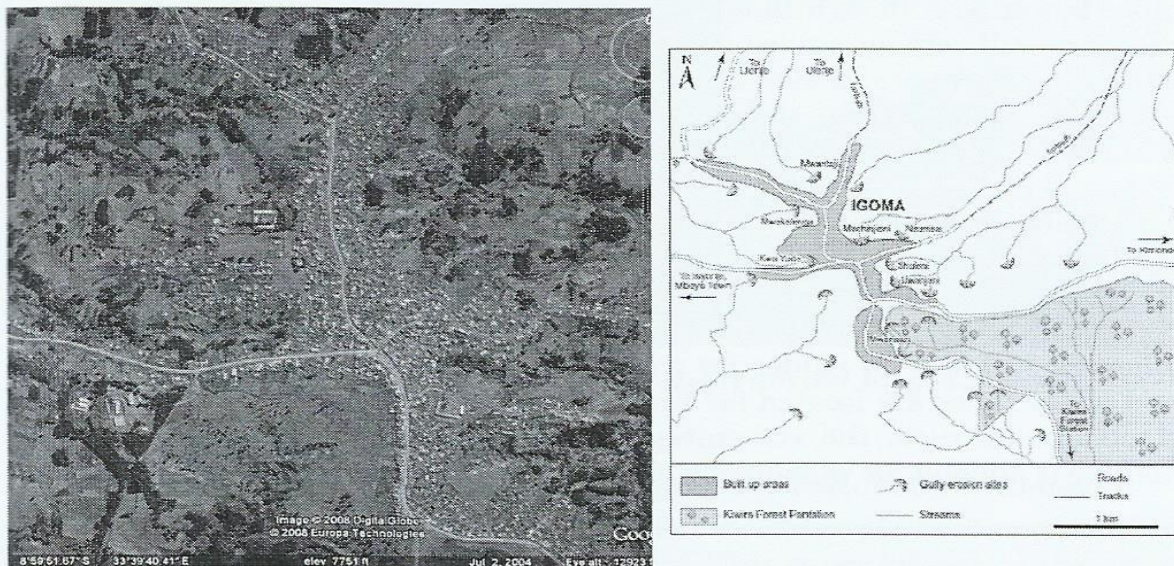
Figure 2: Aerial view of Igoma village and distribution of main gully sites

Figure 2 shows the structure, form and distribution of a greater part of Igoma village and the map shows the distribution of the main gully sites that surround and threaten destruction from all sides. Despite this danger no sustainable measures have been undertaken to check land degradation and gully extension. The sustainable management of the village's headwater areas calls for a better understanding of the human – environment interactions that have taken place in the village.

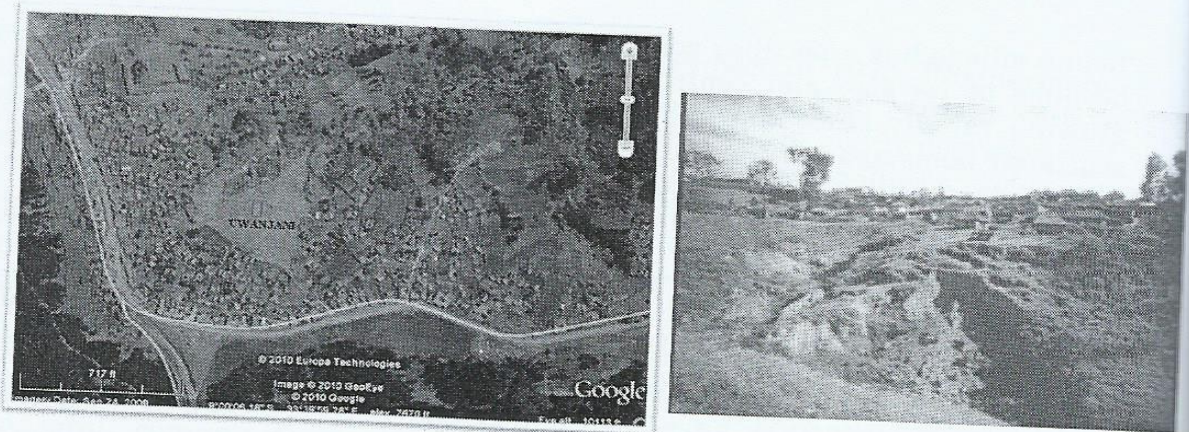
Figure 3: View of Uwanjani gully and built-up areas threatened by gully extension

Gully formation and its headward extension have impact on agricultural land and built-up area. Gully extension occurs through slumping of land at the gully head following heavy rainfall. Land suitable for agriculture and settlement is degraded in the process. Destruction of houses is reported at Kiwanjani area where landslides occurred on the sides of the gully several times (Fig. 3).

The distance from heads of gullies to built-up areas decreases though gradually, at Uwanjani, Kwa Yuda, Nzumba, Machinjoni and Mwantaji sites (Plate 1). At Uwanjani, the gully is only 60 meters from the local government

The stream gullies also are a threat to infrastructure. A gradual destruction of a bridge at Mwansazi eventually led to a diversion of the road that links Igoma with the Kiwira Forest Plantation station and serves as an outlet for sawn timber that reaches urban markets of Mbeya and Dar es Salaam (Fig. 4). Footpaths joining ridges are abandoned and farmers are forced to use longer routes to reach fields and neighbours. Gully erosion has gradually reduced the size of the football ground at Uwanjani (a 'natural stadium' as villagers could watch games from their homes) that has eventually been abandoned as it became too small and more risky to players (Fig. 3 above).

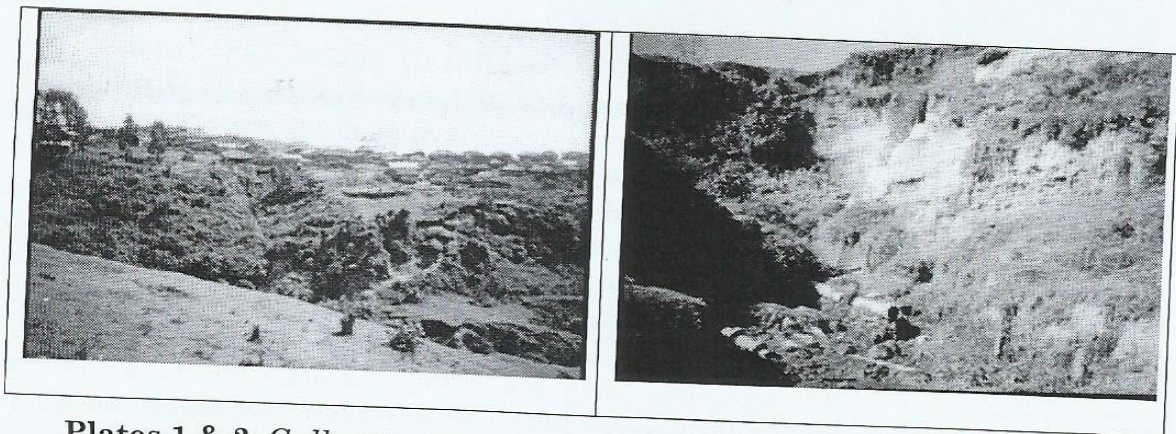
Plates 1 & 2: Gully extension into built up areas and structures for water collection

The distance from heads of gullies to built-up areas decreases, though gradually, at Uwanjani, Kwa Yuda, Nzumba, Machinjioni and Mwantaji sites (Plate 1). At Uwanjani, the gully is only 60 meters from the local government office building. Although the village has piped water supply since 1999, some villagers still rely on gullies for water because piped water supply is erratic, and water tapes are located far from the homesteads. Slumping of gully head structure destroys the structures constructed for drawing water (Plate 2) making it difficult for women and children to fetch water.

office building. Although the village has piped water supply since 1999, some villagers still rely on gullies for water because piped water supply is erratic and water tapes are located far from the homesteads. Slumping of gully head structure destroys the structures constructed for drawing water (Plate 2) making it difficult for women and children to fetch water.
